RCRA Compliance Evaluation Inspection Summary

KMG Bernuth
502 S. 15th
Elwood, Kansas 66024

Inspection Date: June 9, 2010

KDHE Inspector: Laura D. Routh
Bureau of Environmental Field Services (BEFS)
North East District Office (NEDO)

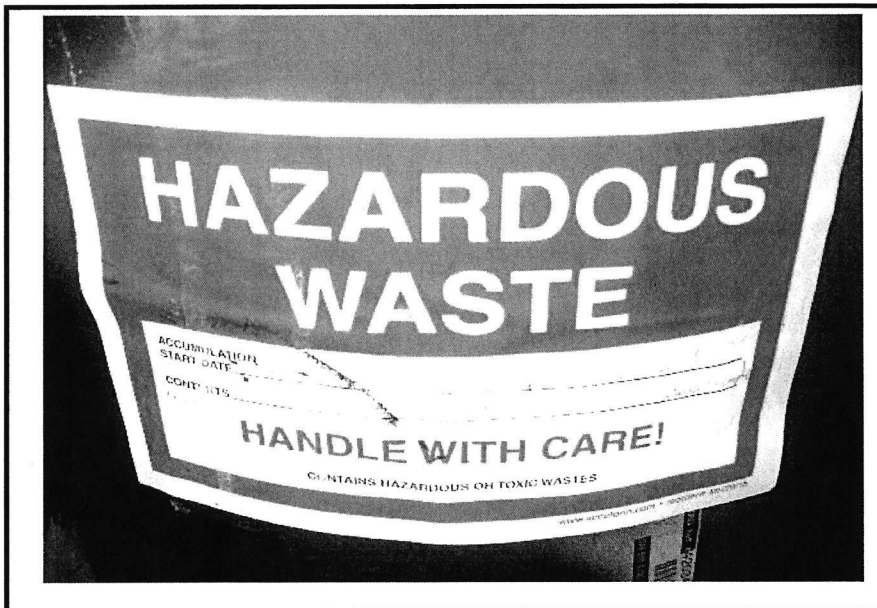
Photo No.:	7
Archive Disc File No.:	P1060984
Date:	June 9, 2010
Time:	10:57 AM
Location:	analytical lab
Direction Faced:	E
Weather Conditions:	hot, sunny
Comments:	Accumulation start date on can is 6/4/10, approximately 5 days prior to the inspection.

Violation 2: KAR 28-31-4(j)(1). Use of more than one satellite accumulation container for the same waste stream at the same location. At the time of the inspection, I observed two 5-gallon metal cans, both containing hazardous waste solvent and reagents, in the same hood inside the analytical lab. One was marked with an accumulation end date of 6/4/10 and the other was marked with a start date of 6/4/10. I explained to Ms. Parry that because the full container had been left in place in the hood for more than 3 days, and not transferred to the storage area, thus a violation was being cited. See photos 6-8.

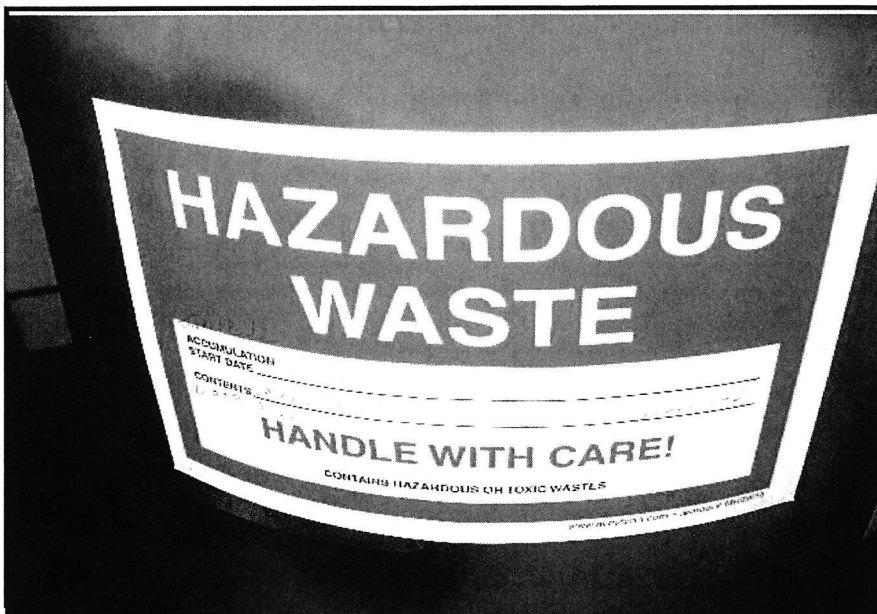
Photo No.:	8
Archive Disc File No.:	P1060985
Date:	June 9, 2010
Time:	10:57 AM
Location:	analytical lab
Direction Faced:	E
Weather Conditions:	hot, sunny
Comments:	This containers began receiving waste on 6/4/10, the same day that the containers shown in photo 8 became full.
